Kenwood TS940 repair notes: low power output, low RX sensitivity.

By Pedro M.J. WYNS ON7WP – AA9HX (email: aa9hx@arrl.net)

These repair suggestions might also apply to the TS930 and TS950 sharing certain circuits.

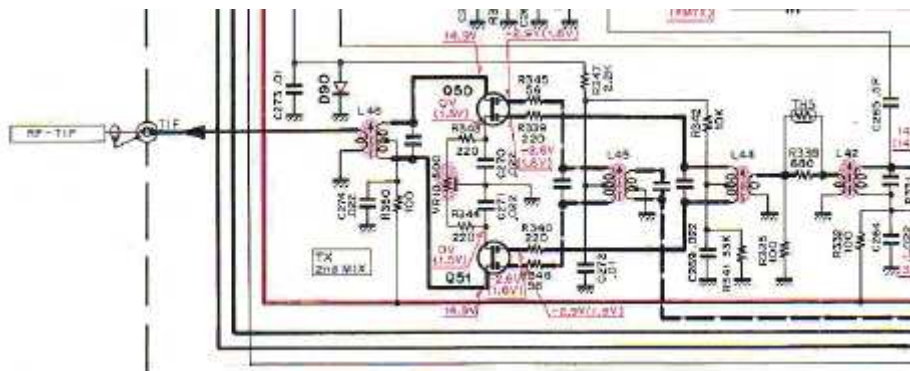
After several hours of searching and more sleepless nights I decided to start retuning the cores, something I usually never attempt unless the radio belonged to a CB-amateur. This was definitely not the case as I suspect the radio was never opened before. Then I discovered the purple cored 45 MHz IF transformer on the IF board was completely misadjusted, even worse, maximum output coincided with a totally screwed-in core. Not normal...

This transformer type has a built in parallel capacitor, that obviously became too small. Only one explanation I have: ageing... The cure was mounting an external capacitor of 27 pF over the two 56 ohms resistor ends going towards the gates of Q50 and Q51. L42, L44 and L46 also needed some slight readjustment, but the difference with L45 was over 30 dB !

On the schematic diagram you can see **L45** and the built-in capacitor printed on the drawing without a value next to it. The cure is adding an external capacitor at this point.

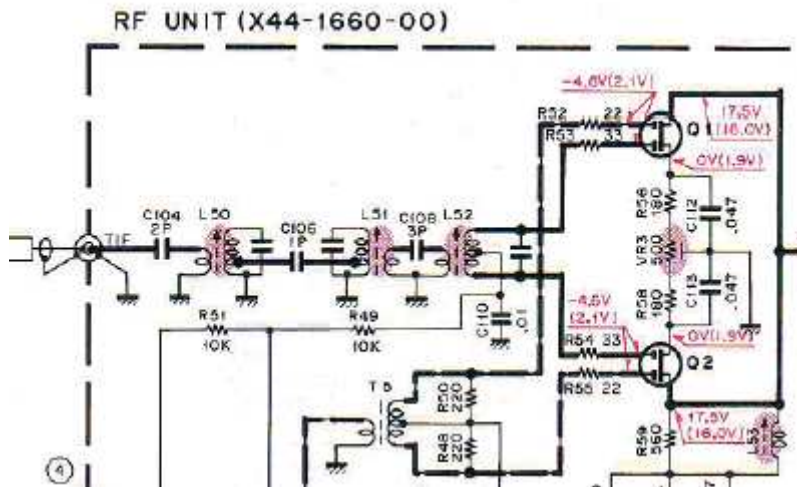
On the RF board retuning the input coils L50, L51 and L52 also scored a few dB gain.

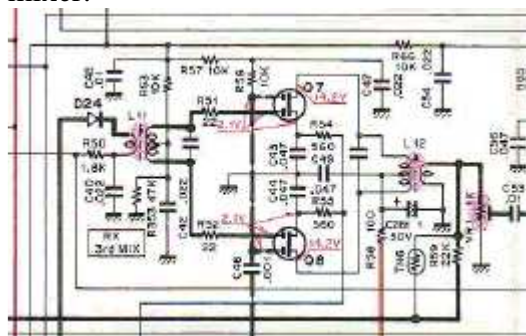
The same problem was found in L41, the 45 MHz IF transformer at the input of the third RX mixer:

It is impossible to tune this transformer. I suspect the internal capacitor had changed his value due to chemical processes. It is the very same purple core device as in the TX chain. The solution is similar: add a capacitor between both 22 ohm resistors at the opposite end of the gate. Then it tunes flawlessly.

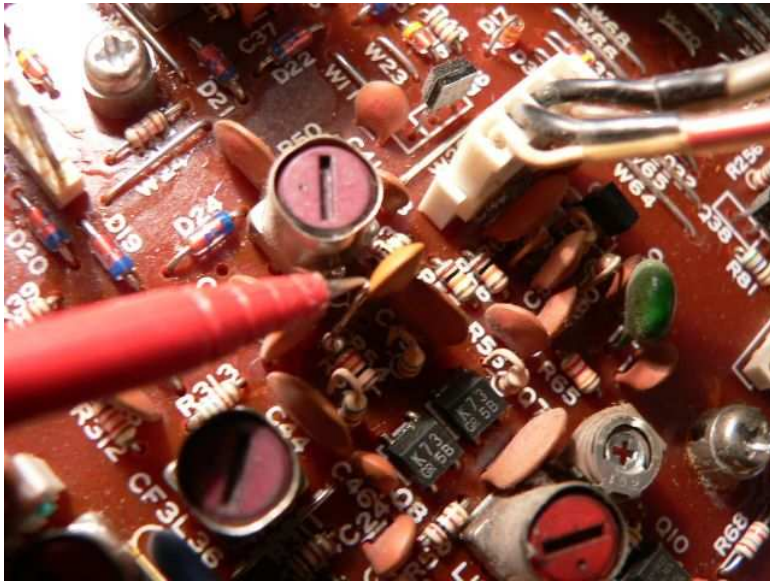
IF ageing in RX IF plus added capacitor 27 pF:

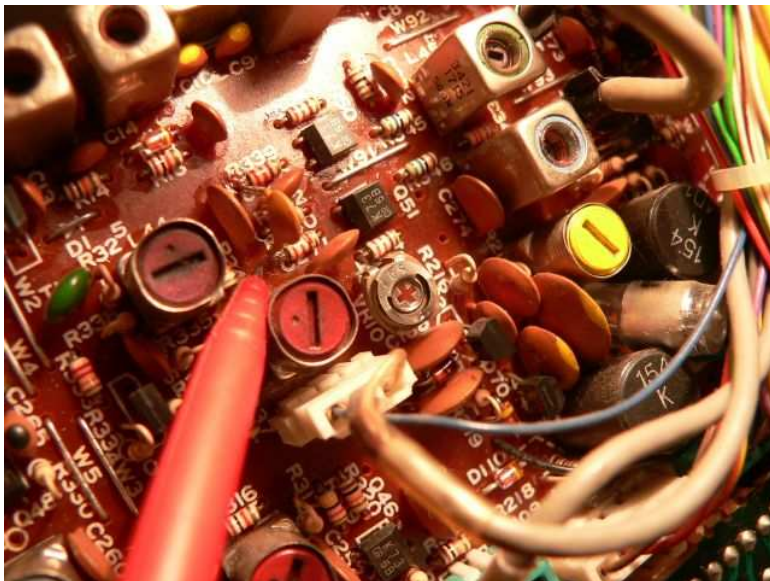
IF ageing in TX IF plus added capacitor 27 pF:
